# Selling Arguments *for* TIN ROOFING

*A review of the advantages of  
roofs of this type*

A textbook containing corrected tables for use in estimating, instructions for laying tin roofs, description of the manufacture of roofing tin, and a large amount of information useful to the practical man.

N. & G. Taylor Company, Philadelphia

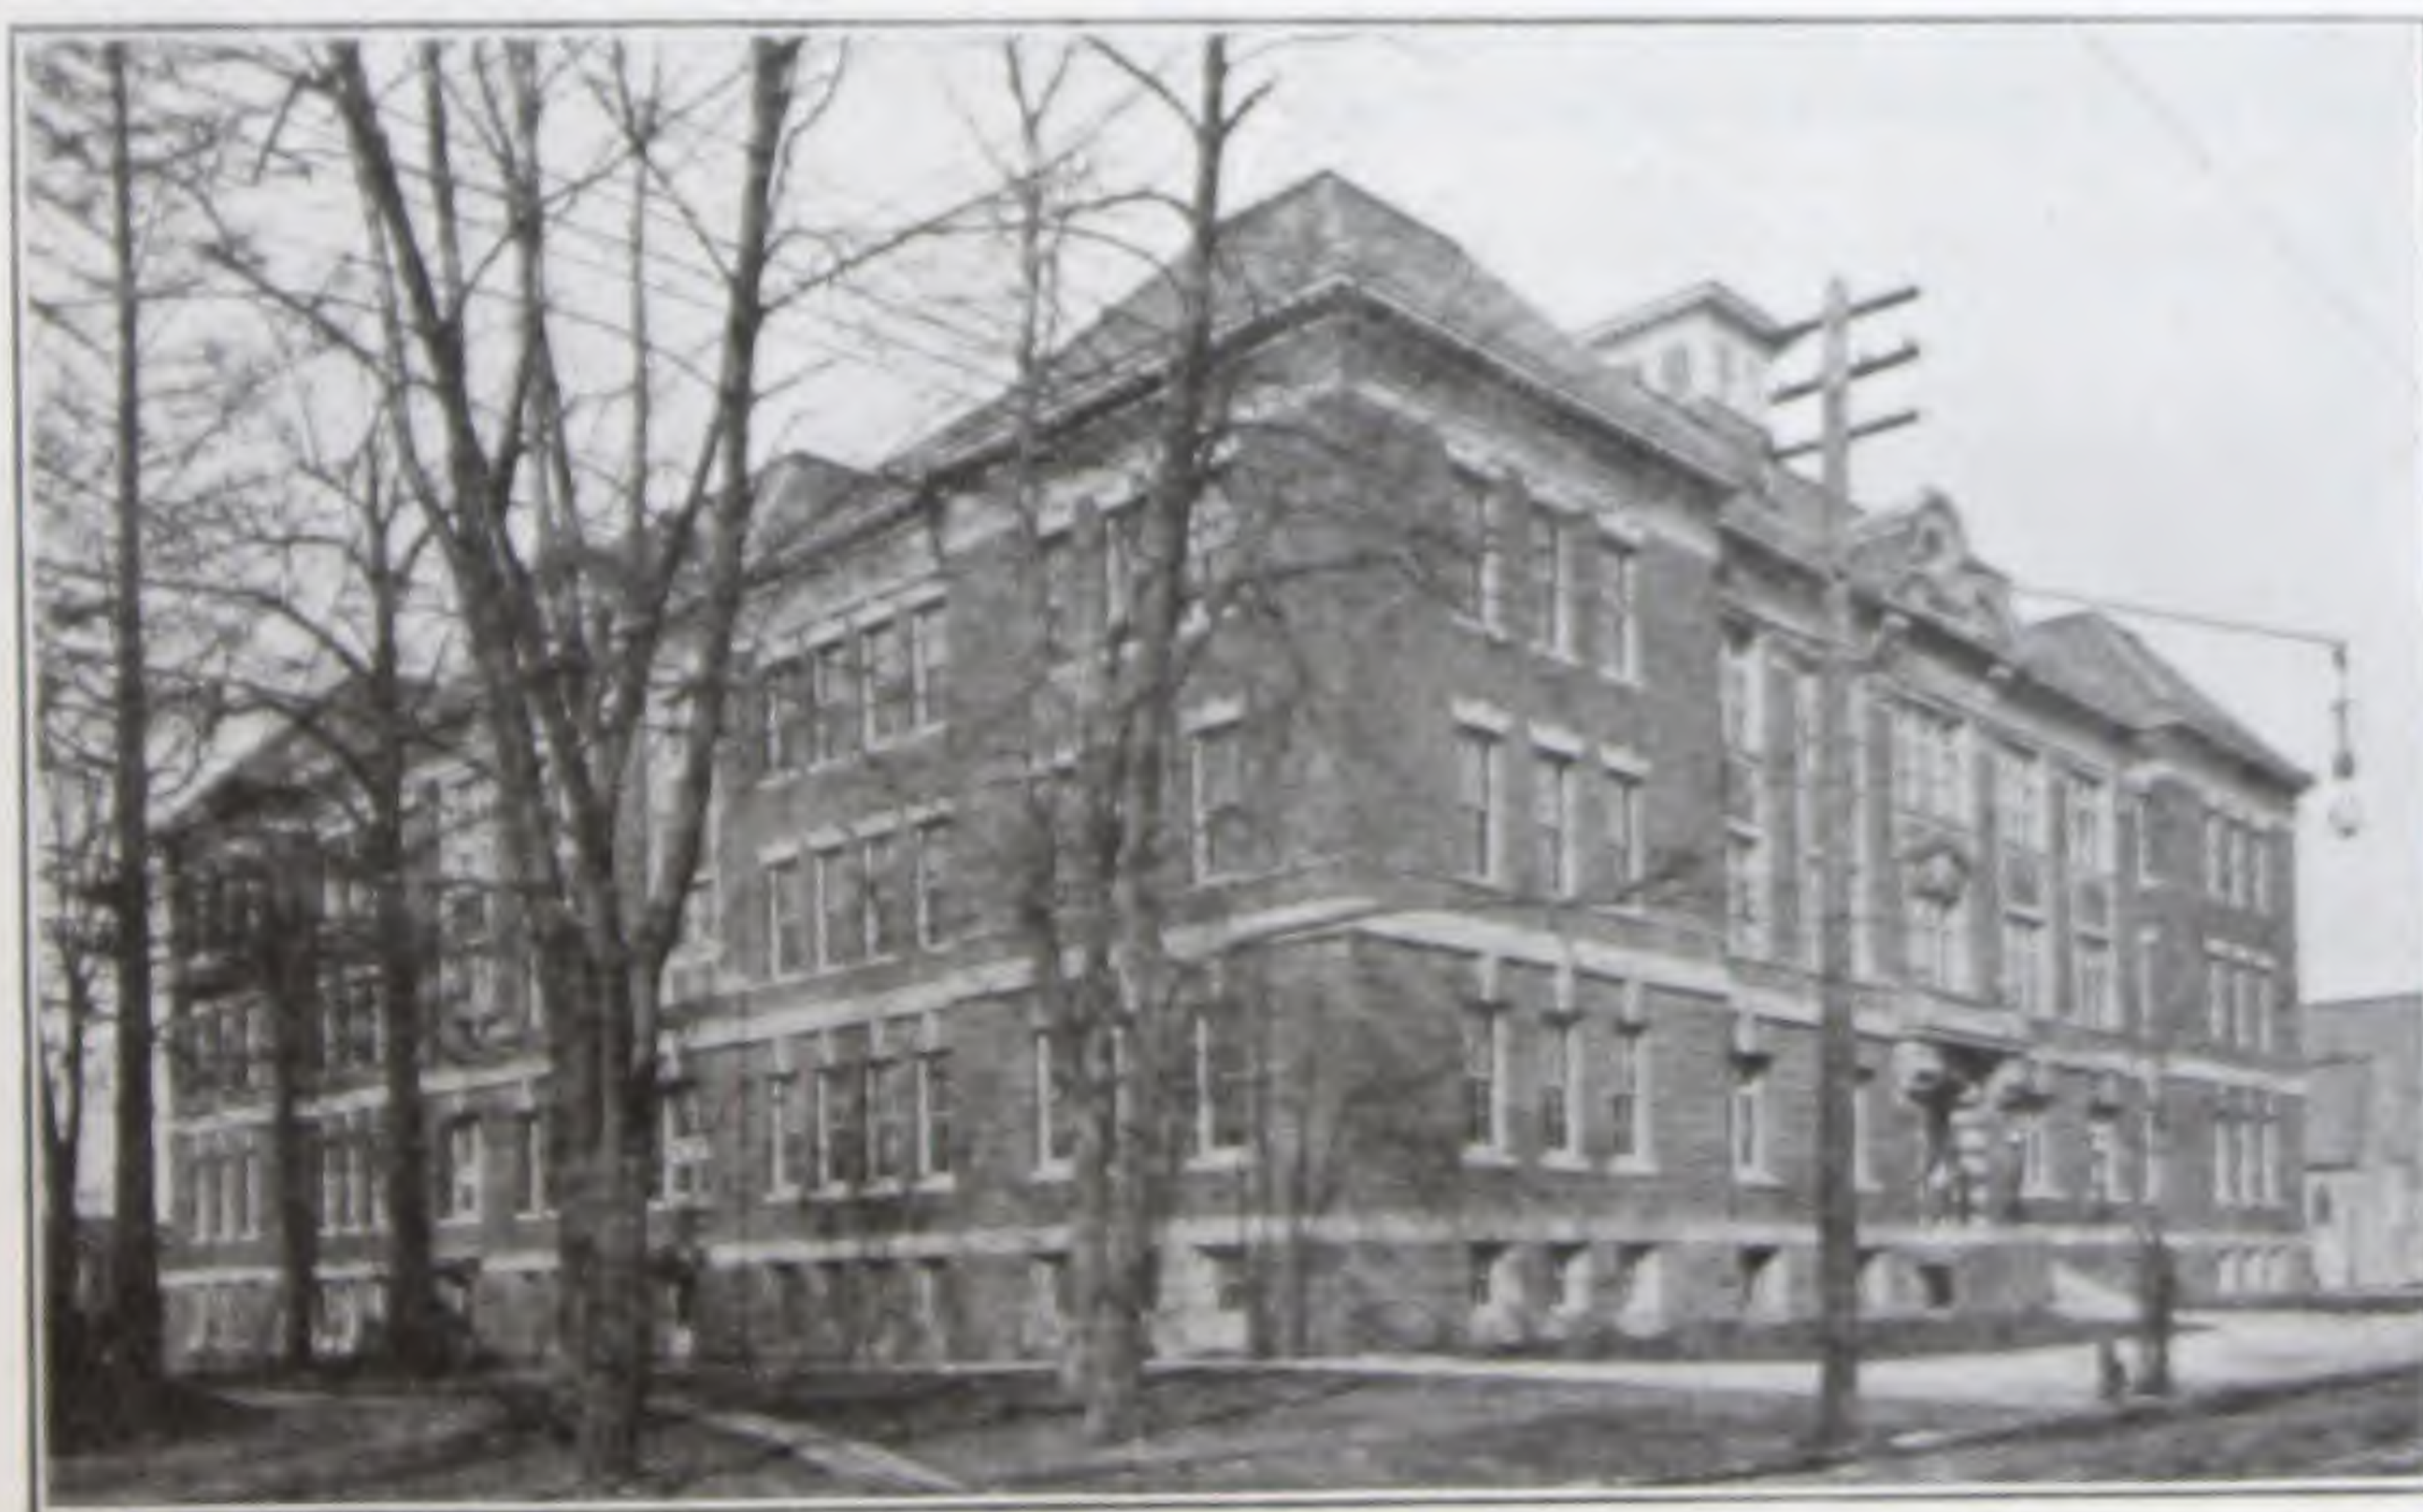
**53. NOTABLE TIN-ROOFING CONTRACTS:** Wilmington, Del., High School building, roofed with Target-and-Arrow tin in 1893. 14" x 20" sheets laid part standing-seam and part flat-seam, with cleats. Painted with metallic brown paint. Roof remains in first-class condition.

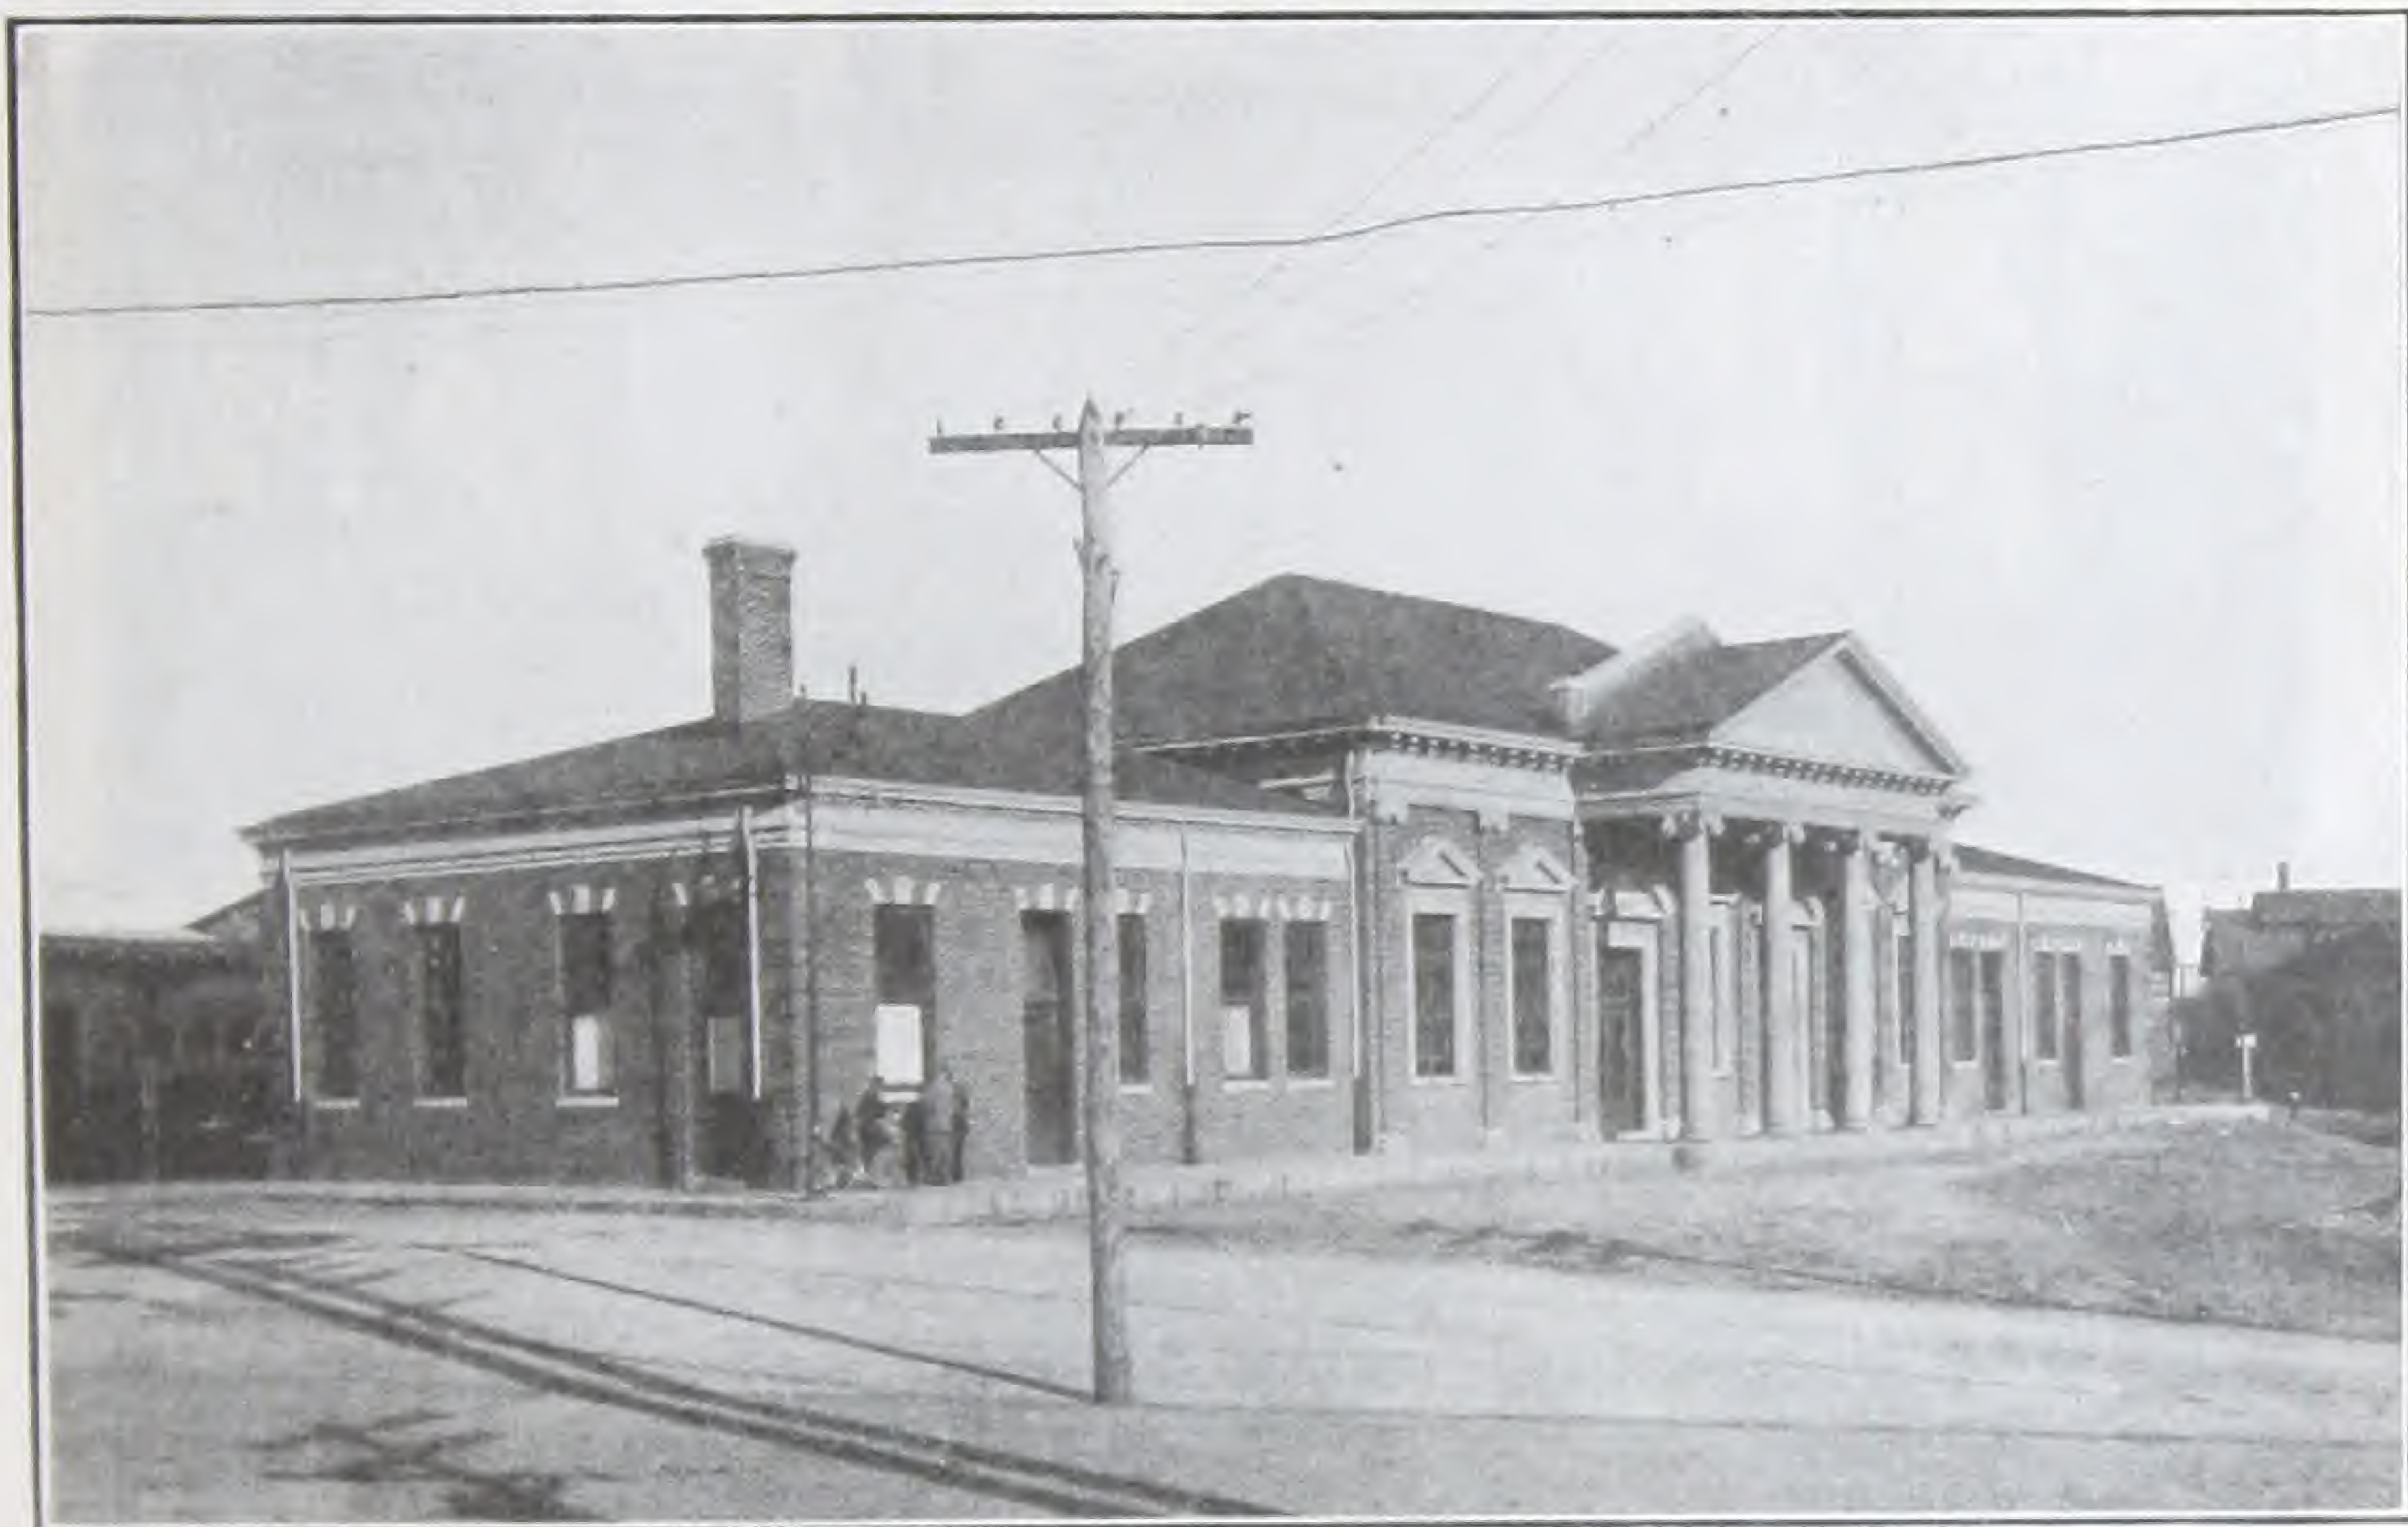
**56. NOTABLE TIN-ROOFING CONTRACTS:** Norfolk & Western Railway Depot, Petersburg, Va. Roofed with 6000 sq. ft. of Target-and-Arrow tin by Brunet & Somers, roofers, Petersburg, Va.

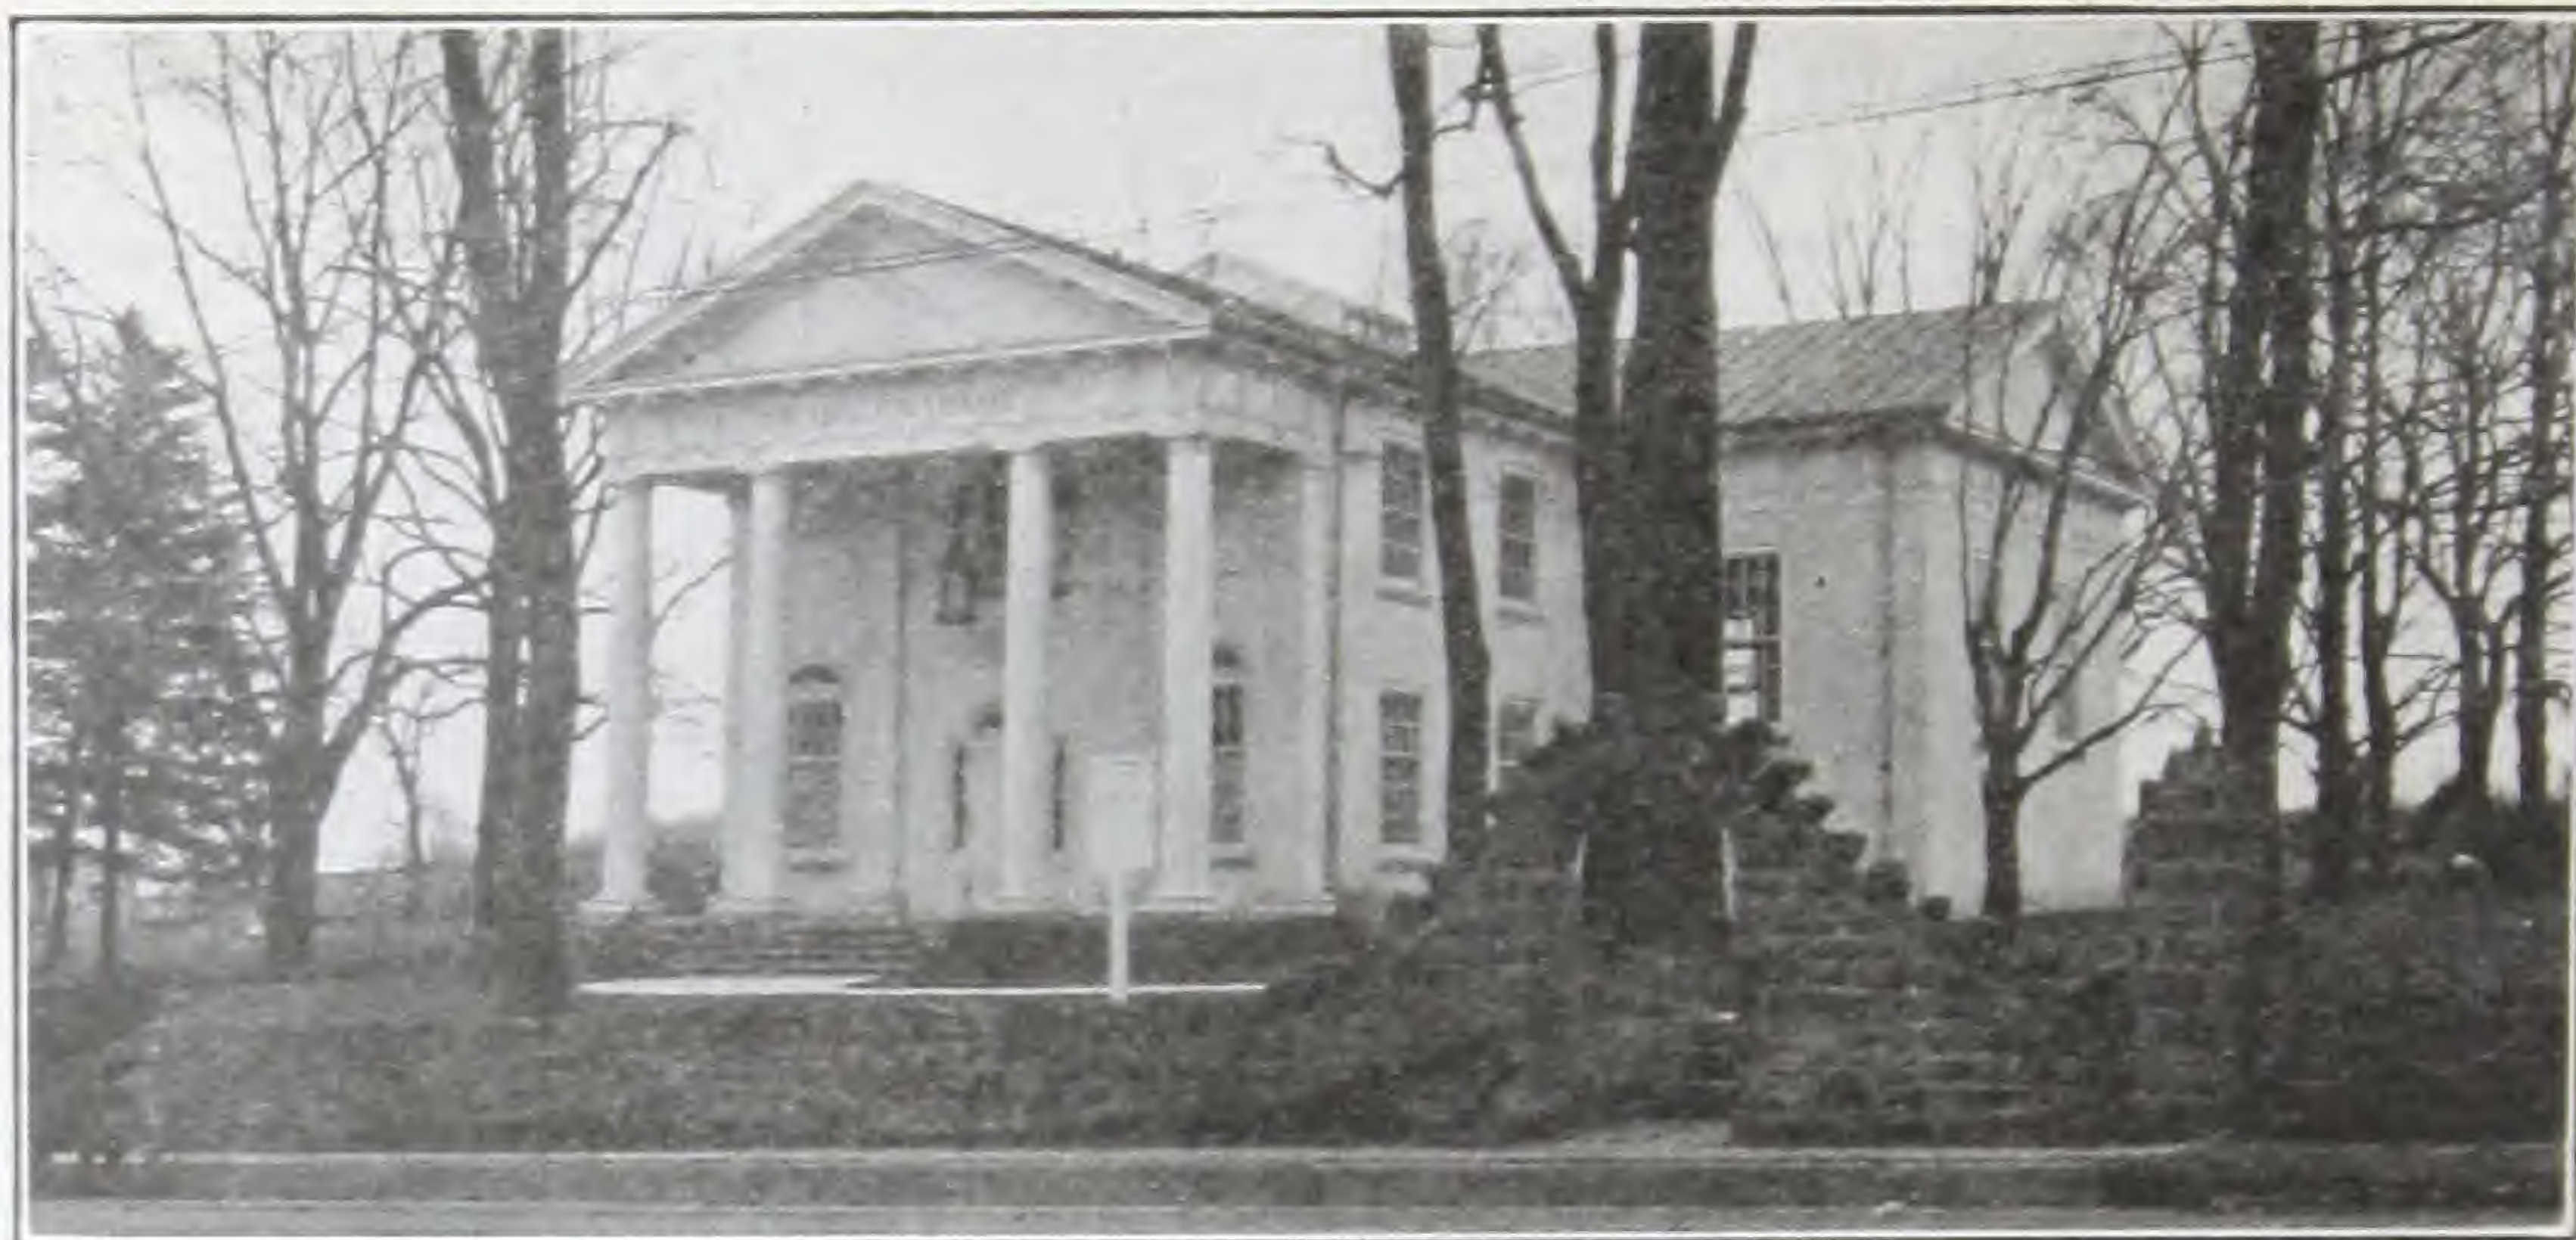
**58. NOTABLE TIN-ROOFING CONTRACTS:** The Abington Library, Jenkintown, Pa. An interesting landmark on the Old York Road, near Philadelphia, dating back to 1857. Covered with Target-and-Arrow roofing tin, IX thickness, laid with standing seams. W. C. Fleck & Bro., roofers, Jenkintown, Pa.

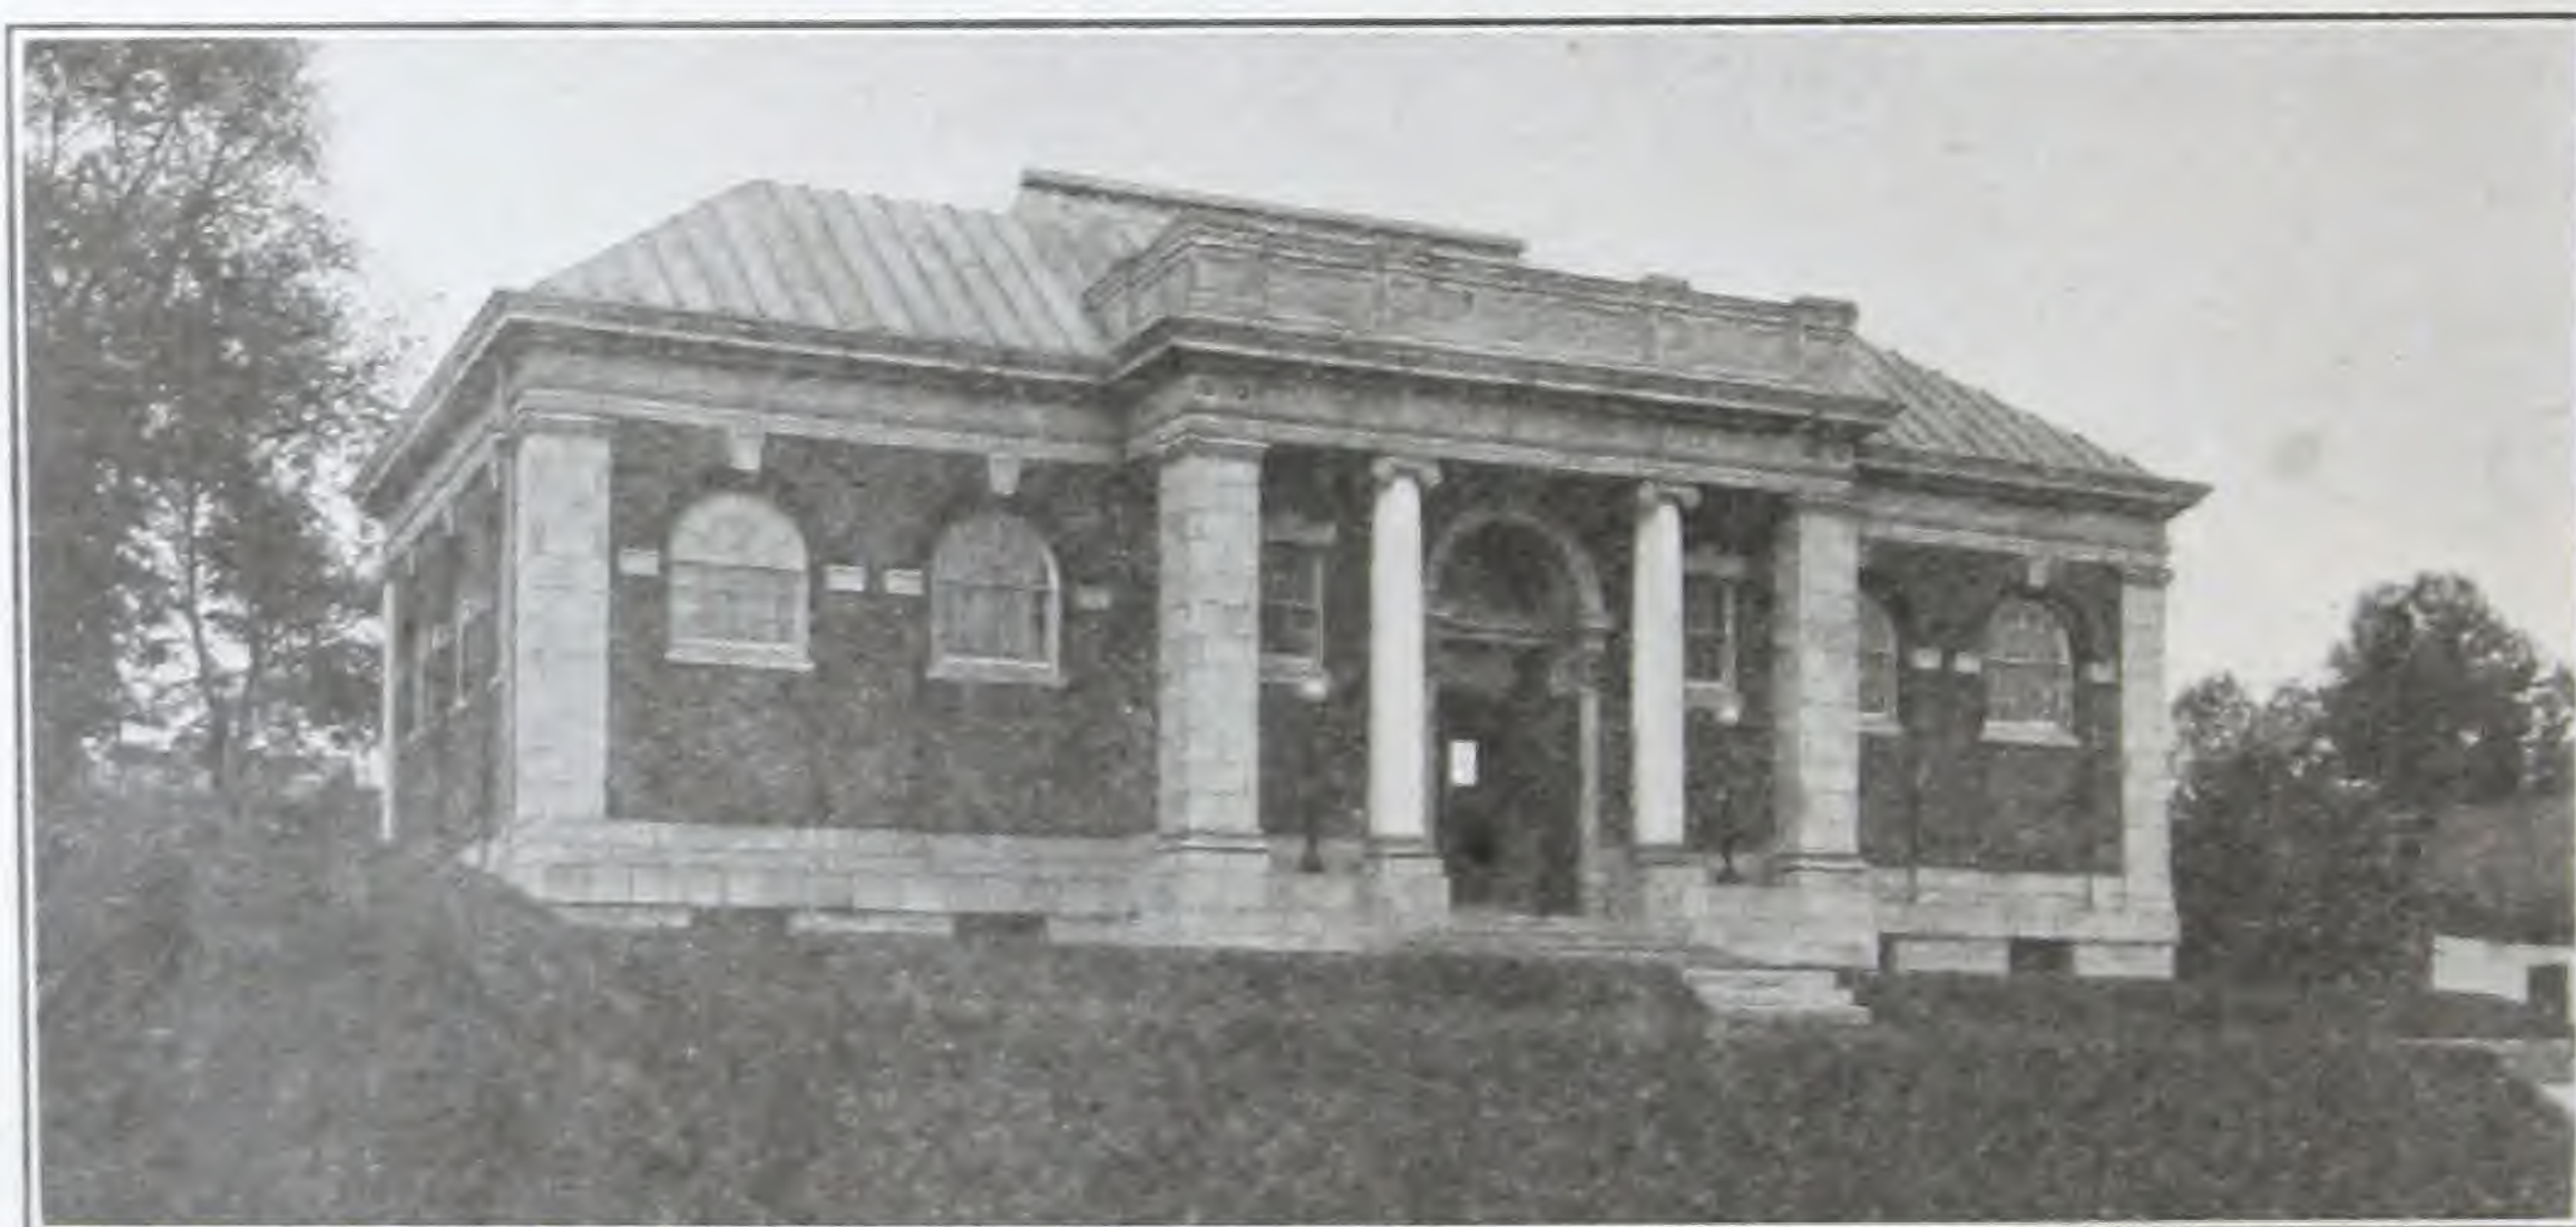
**59. NOTABLE TIN-ROOFING CONTRACTS:** Wissahickon Branch, Free Library of Philadelphia, Wissahickon, Pa. Roofed with Target-and-Arrow tin, IX thickness. H. Ottinger & Co., roofers, Philadelphia. A good illustration of the heavy ribbed effect secured by shaping the tin over wood strips. Roofing tin laid in this way gives the appearance of a copper roof, especially if painted green. Such a roof has all the durability of copper, and is free from the broken seams, costly and difficult to repair, caused by the high co-efficient of expansion of copper. Leaks of this kind in copper roofs often cause heavy damage to interior decorations and fittings. Good tin solves this problem completely.

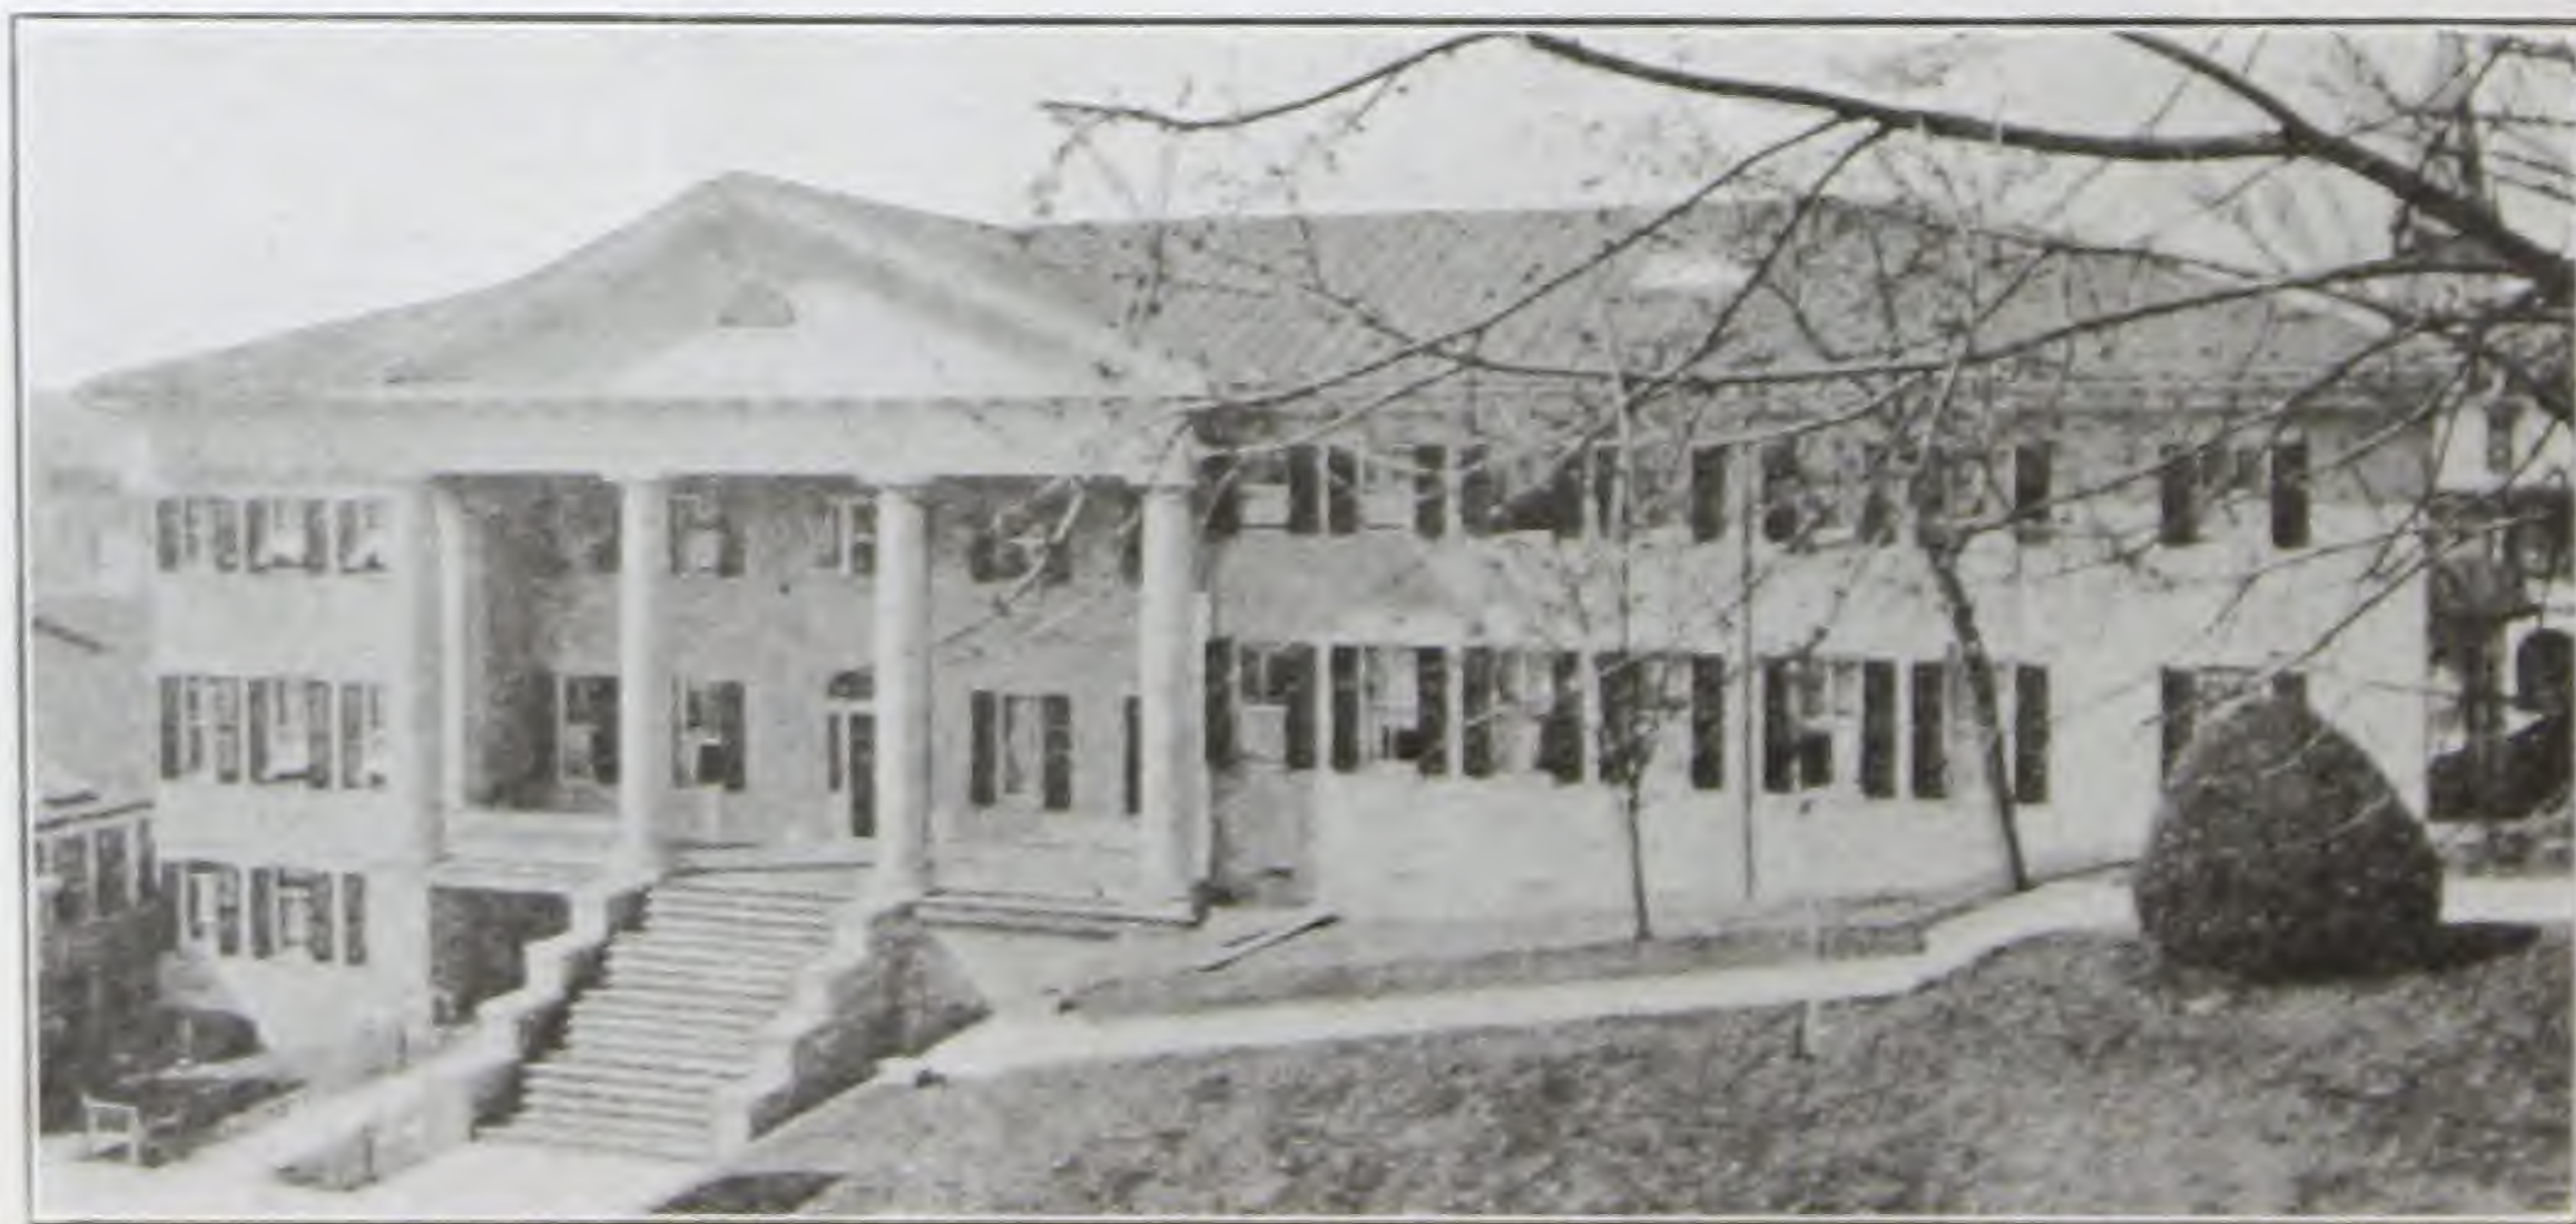
**60. NOTABLE TIN-ROOFING CONTRACTS:** Agnes McClung Hall, Mary Baldwin Seminary, Staunton, Va. Nolan & Baskerville, architects, Richmond, Va. Roofed with Target-and-Arrow tin laid standing seam. Numerous other buildings at this institution are roofed with this tin.

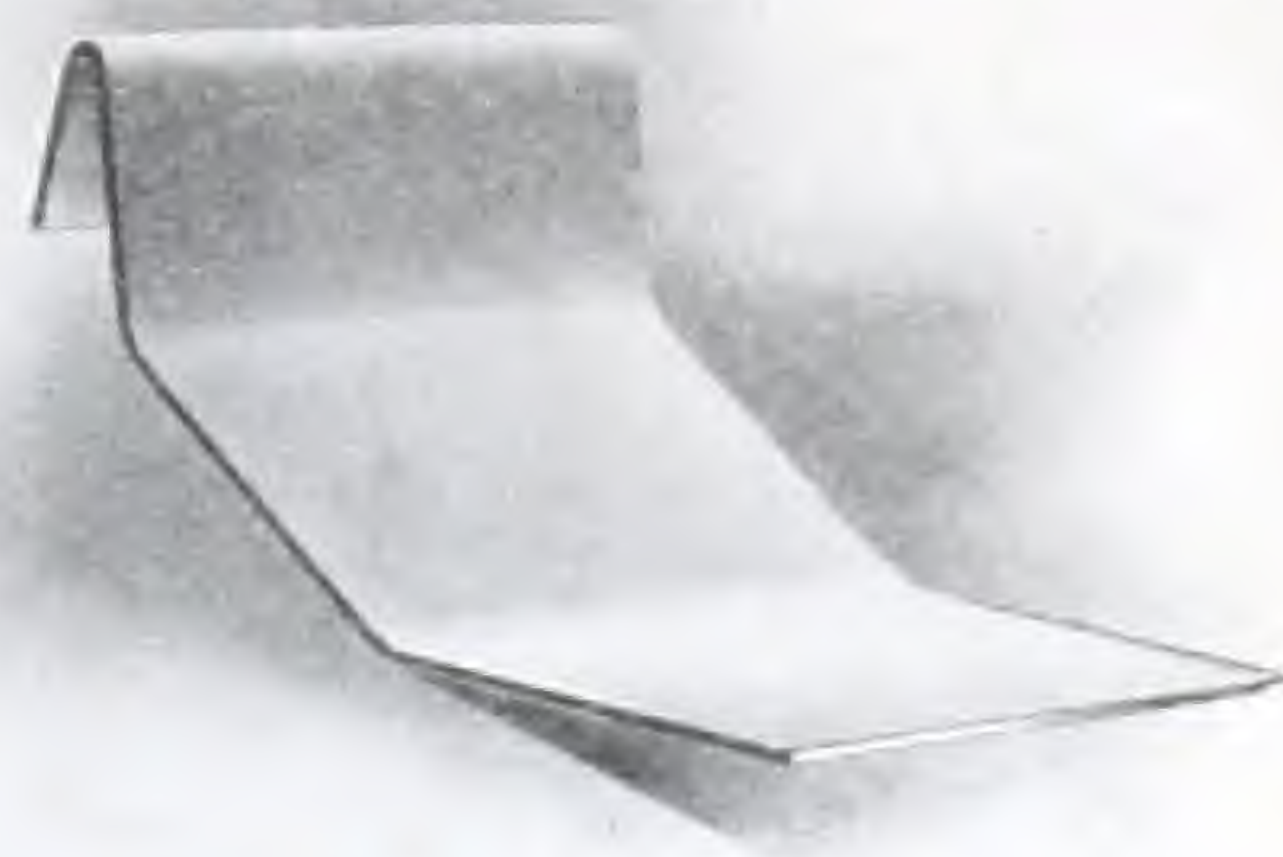
Illustration 61. *Fig. A*

**TIN ROOFING CLEAT.** Used for fastening the sheets to the roof boards. See page 49 and following illustrations.

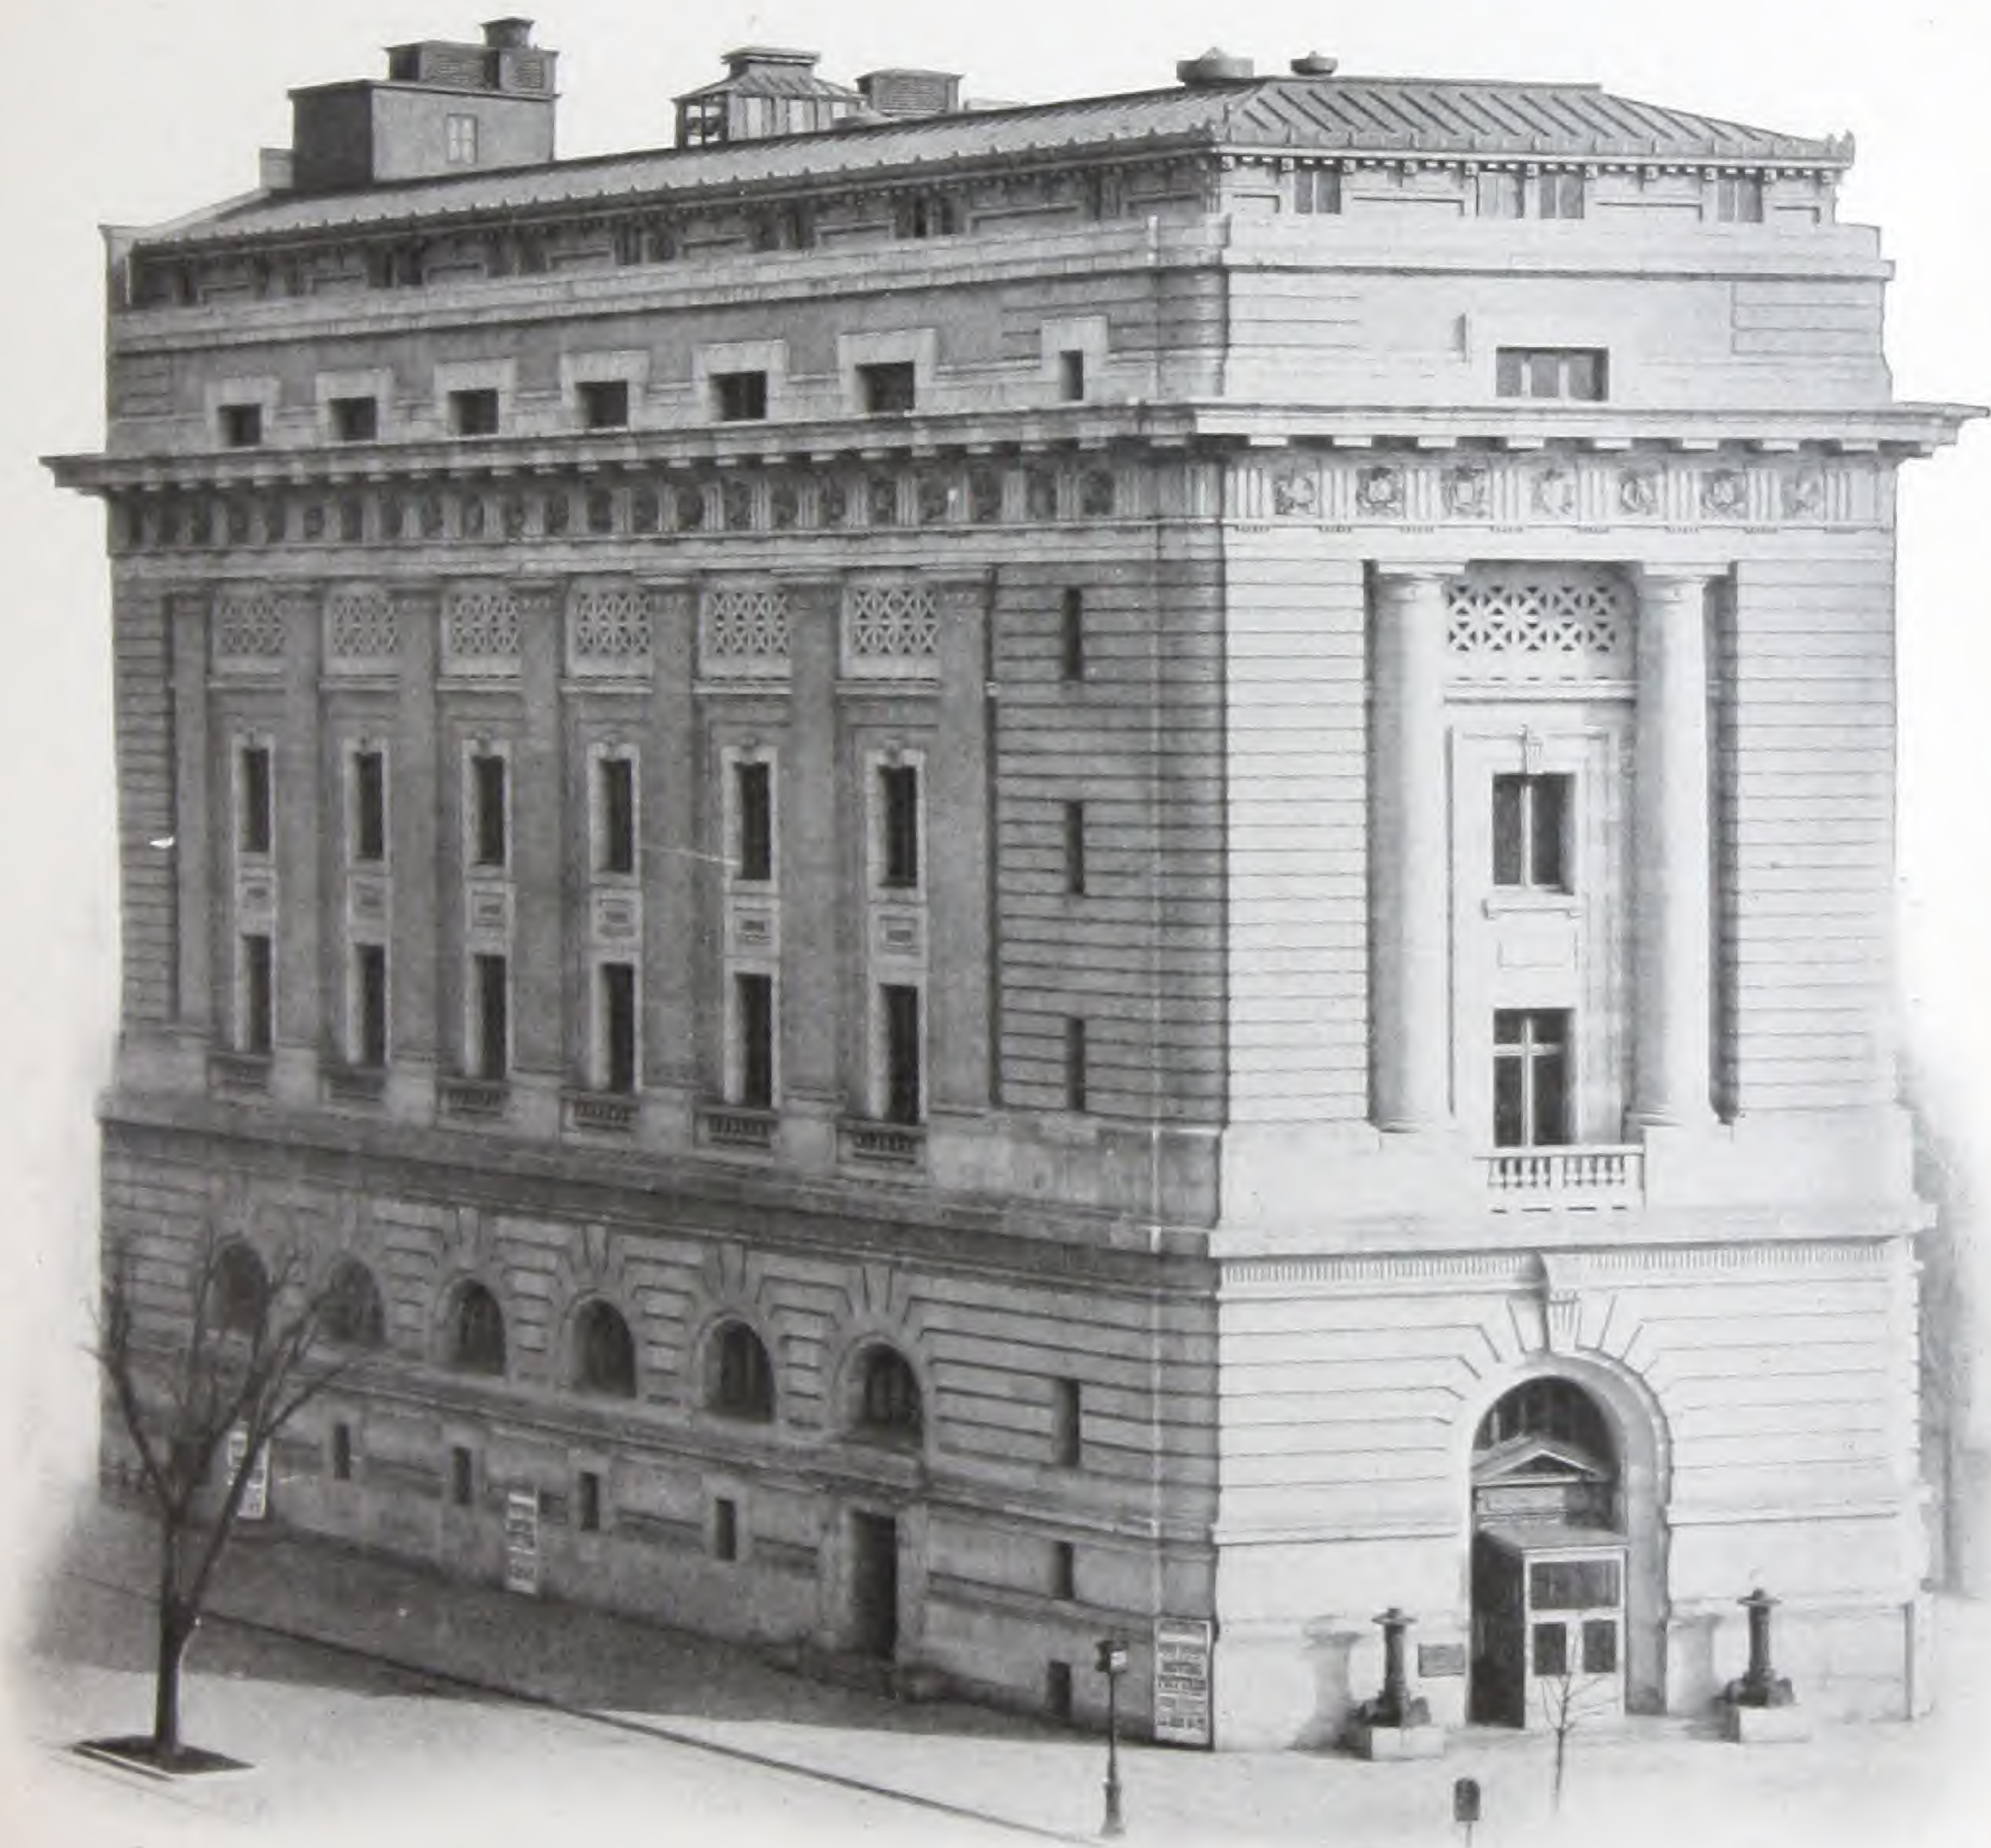
### NEW MASONIC TEMPLE, WASHINGTON, D. C.

Roofed with Target-and-Arrow tin. On the visible parts of the roof the tin is laid over wooden strips, to get the desired ribbed effect, as clearly shown in the photograph.
